Conversion of a natural gas pipeline to hydrogen transport and the effects of impurities on the hydrogen quality

Henk Top
DNV Energy Systems, Groningen, The Netherlands

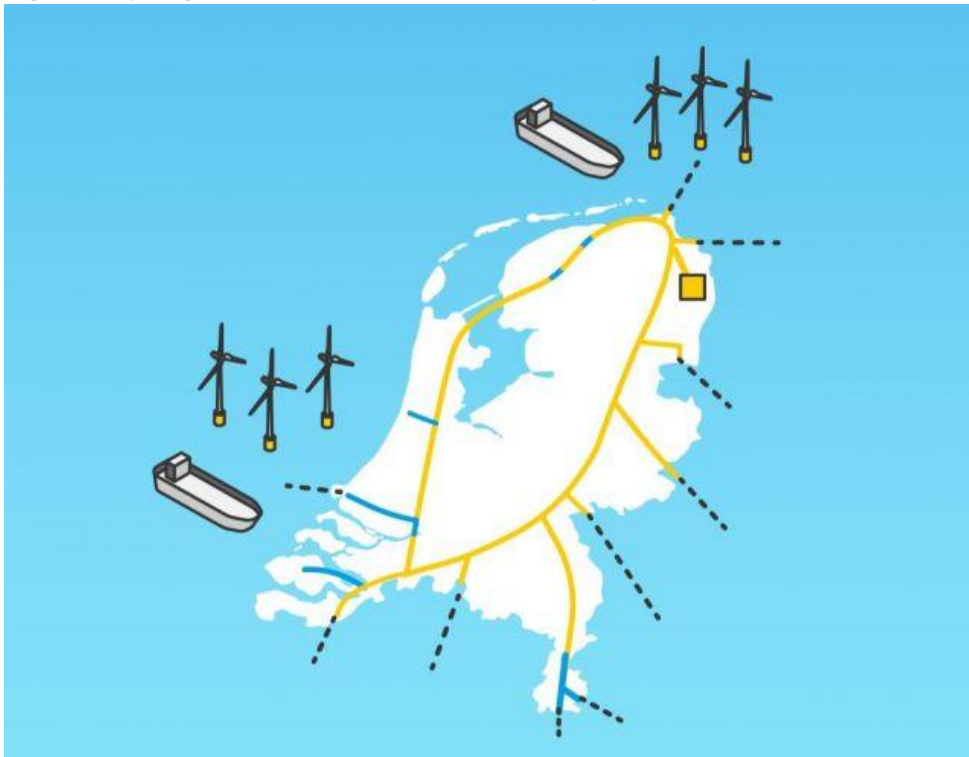
Figure 1. Hydrogen backbone in the Netherlands (Hynetwork Services).

Hydrogen as a general substitute for natural gas for heating, chemical feedstock and for power generation is new for the Netherlands. Completely new chains will have to be set up in which the supply of hydrogen is linked to the market - initially the industries that need hydrogen for high-temperature processes and as a 'green raw material' for artificial fertilizer, for example. In order to establish this new chain, a robust transport network must be in place in good time, as the 'backbone' for this new chain. A large part of this backbone will exist of former natural gas pipelines, see figure 1.

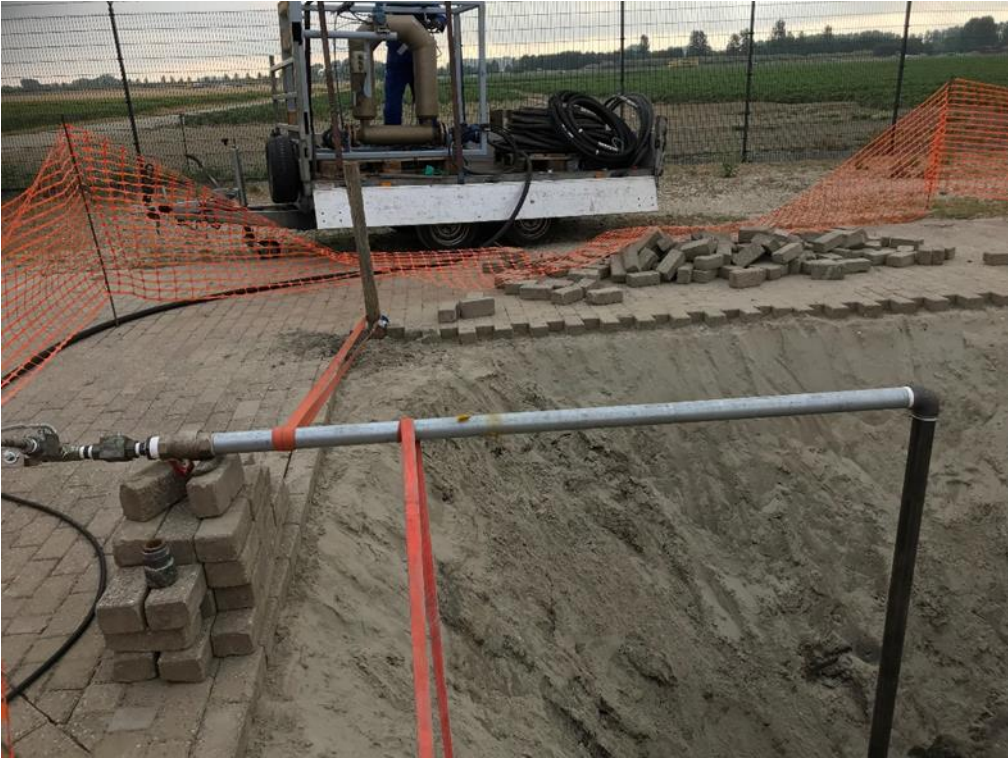
Figure 6. Nitrogen injection DN50, Coriolis flowmeter on the background.

In preparation for displacing the pipeline content, a DN50 connection was made for injecting nitrogen (see figure 6). In addition, a DN100 vent stack approximately 4 meters high was installed at the other side of the pipeline for venting (see figure 7). This vent stack was equipped with a sample point. On this sample point, a water dew point sensor (Michell Easidew, measuring range -100 to +20 degrees Celsius) was mounted. The outlet of the sensor was equipped with a Teflon sample line (6 mm OD) to the measuring equipment. This equipment consists of a flame ionization detector (Thermo FID, model TG from the company Mess- & Analysentechnik GmbH) and an Agilent Technologies 490 Pro micro-GC. The water dew point sensor and the FID (measuring range 0 - 1000 ppm C_xH_y) were used to monitor the displacement process in real time. The FID was calibrated with a known concentration of propane (C₃H₈) in nitrogen; therefore, the hydrocarbons are presented as propane equivalents.

To inject nitrogen, a nitrogen unit and a Coriolis flow meter from Well Service Group (WSG) was used. The WSG nitrogen unit has a maximum capacity of 1500 m³/h. In principle, it was advised not to let the nitrogen flow exceed 300 m³/h because of vibrations/pulsations and the expected noise level. The calculated theoretical velocity at the entry point DN50 will be around 40 m/s. At the exit point with DN100 diameter it will be around 10 m/s. The maximum stock of the nitrogen unit is 7800 kg of liquid nitrogen (-196 degrees Celsius @ 101.325 kPa). After evaporation, this is a maximum supply of approximately 6250 m³. With this, approximately four times the volume of the pipeline can be displaced at atmospheric pressure.

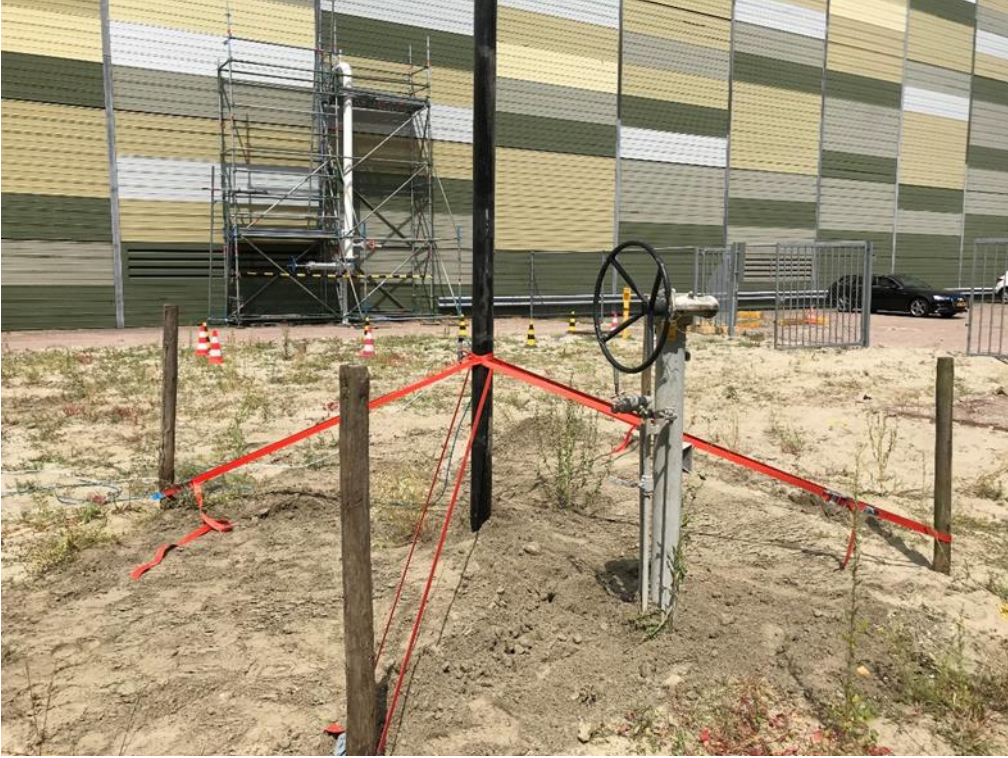
Figure 7. Vent stack DN100.

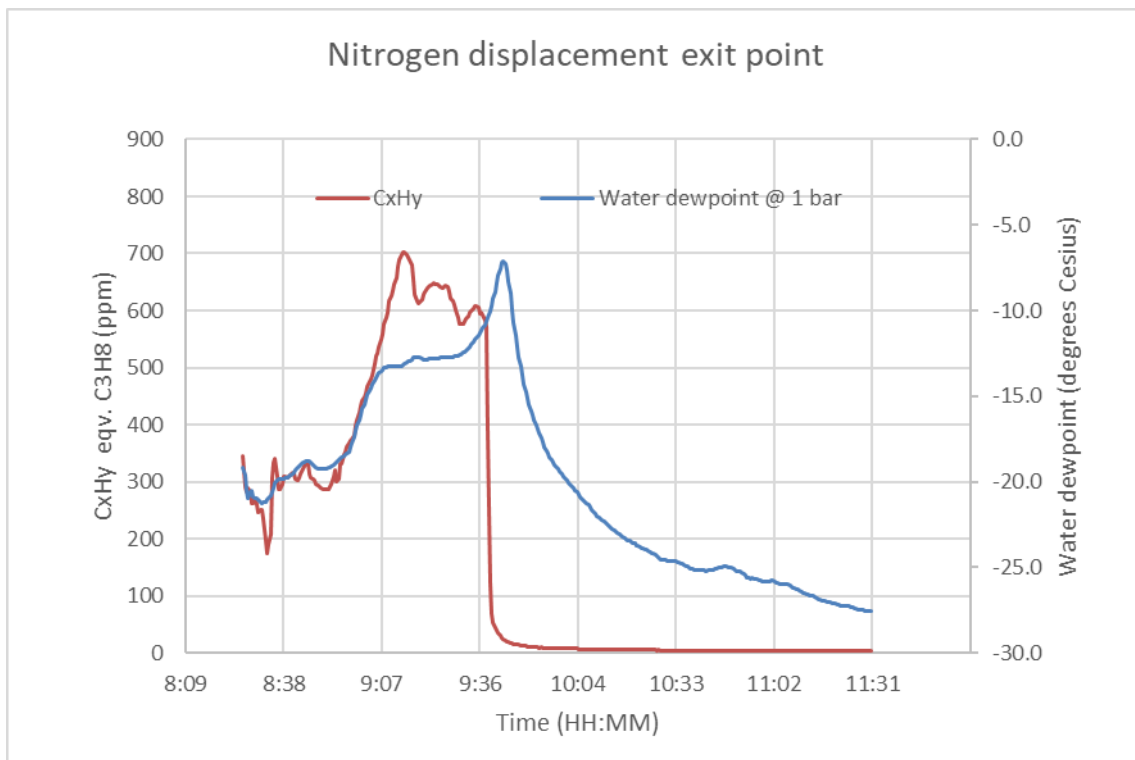
Figure 8. Total hydrocarbons and water dewpoint at exit point.

The measurement results are shown graphically in figure 8 and 9. At the start of the measurements, the water dew point (-20 °C), hydrocarbons (300 ppm) and THT content (15 mg/m³) were stable. From 08:55 hours these values suddenly increased. Around 9:40 hours the total content of the pipeline was purged with new nitrogen. This was very clearly noticeable because of the rapid decrease in the hydrocarbons and the THT concentration. The hydrocarbon concentration dropped from over 600 ppm to approximately 10 ppm in a very short time. The THT concentration decreased from approximately 30 mg/m³ to below the detection limit of the micro-GC. Around 10:40 hours, 3000 m³ of nitrogen had been consumed and at 11:30 hours the nitrogen supply was exhausted. The hydrocarbon content at that time was 3.2 ppm and the water dew point was -27 degrees Celsius (511 ppm).

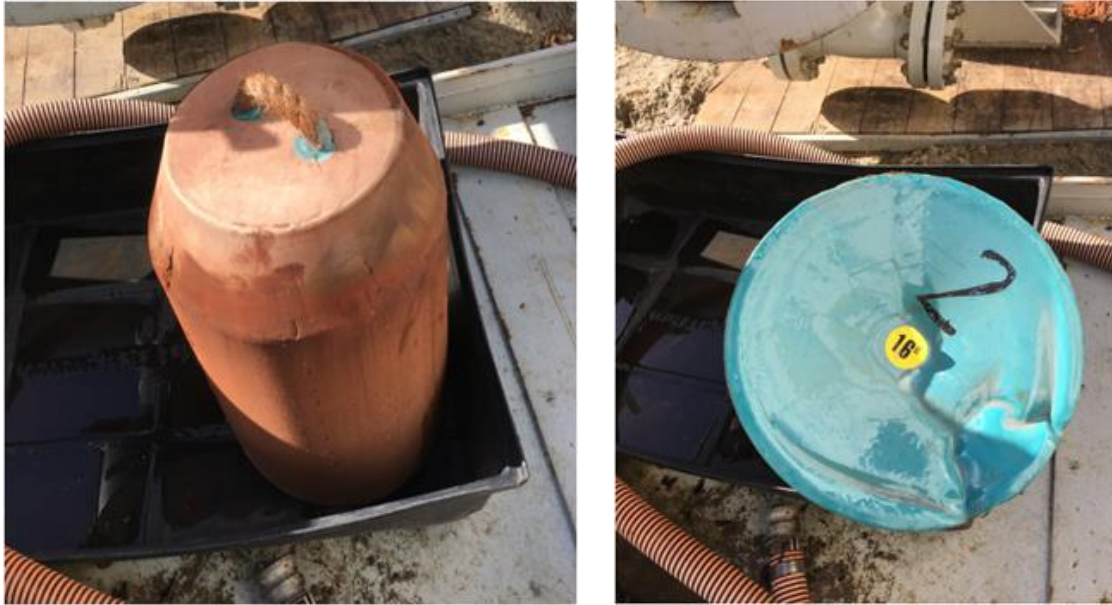
Figure 11. Foam pig, on the left front side and on the right back side.

In October 2018 the former natural gas pipeline was commissioned. The purpose was to deliver an oxygen free and clean pipeline. From the exit point nitrogen was injected using the WSG facility. During the modification of the pipeline two foam pigs were placed at the entry and exit points in order to minimize the entry of air and moisture. These foam pigs were removed during the first nitrogen purge. The foam pig from the exit point travelled through the entire pipeline during this purge to the entry point. This foam pig was clean and dry, see figure 11. The pipeline was filled with nitrogen to a pressure of 4 bara and subsequently blown off. This was repeated two times. The residual oxygen concentration was below 1 ppm. A total of approximately 16,000 m³ nitrogen was used during commissioning.

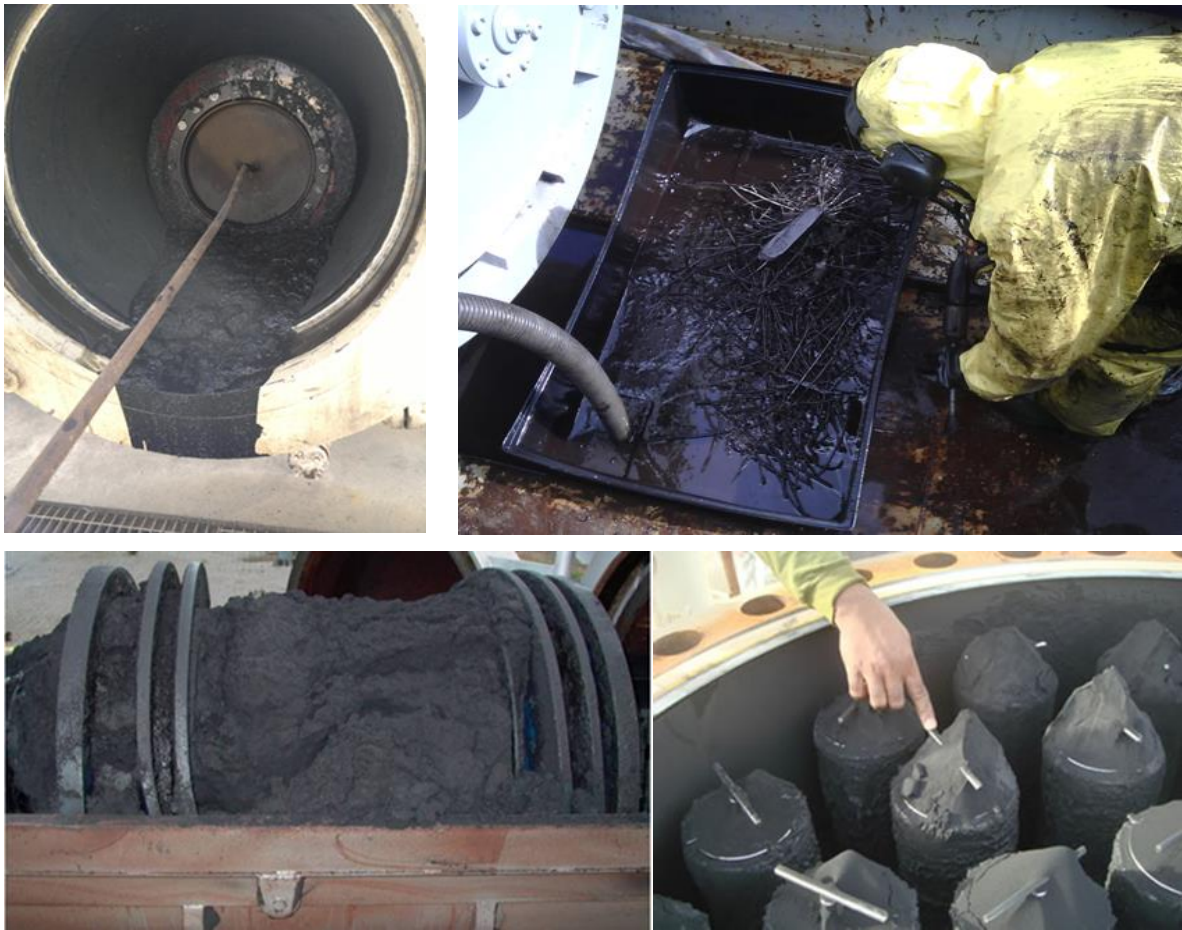
Figure 12. Examples of contaminants found in existing natural gas pipelines.

Most natural gas pipelines are using flow coating, except for the welds. So, hardly any surface rust is to be expected from these pipelines. However, there may be contaminants like black powder, welding deposits, lubricating grease, sand, and liquids such as seal oil, glycol, and natural gas condensates. In general, it can be stated that the pipeline must be dry and free of materials (EIGA 121/14). This can be achieved with several pig-runs. The criterium for the cleanliness is the degree of contamination found on the pig. EIGA describes an assessment based on the penetration depth of the colouring in a foam pig. In addition to pigging, EIGA describes "mechanical scraping" and "high velocity gas purge" to clean pipelines. Due to damage, this is not recommended for pipelines with a flow coating and/or large diameters.

The contaminations found in natural gas pipelines are very diverse. A distinction is made between solids, liquids, and volatile/gaseous components. This last group of components will be largely removed when purged with nitrogen, before switching to hydrogen. The focus is therefore on solids and liquids (volatile or not). The solids consisting of sand, black powder, coating particles, lubricating grease, etcetera, which may or may not have become smeared with oil, glycol, and natural gas condensates. The inner pipeline walls, valves and other equipment are partly contaminated with this "greasy" mass. The amount of pollution present per pipeline section is a question mark depending on the period used for natural gas transmission. In addition, a quantity of liquid can accumulate in sinkers. To be able to estimate the degree of pollution present in a natural gas transmission pipeline, it is necessary to assume quantities and qualitative descriptions as found after performing a pig-run. It should be noted that materials trapped in dead ends and branches are not being removed with a pig-run.

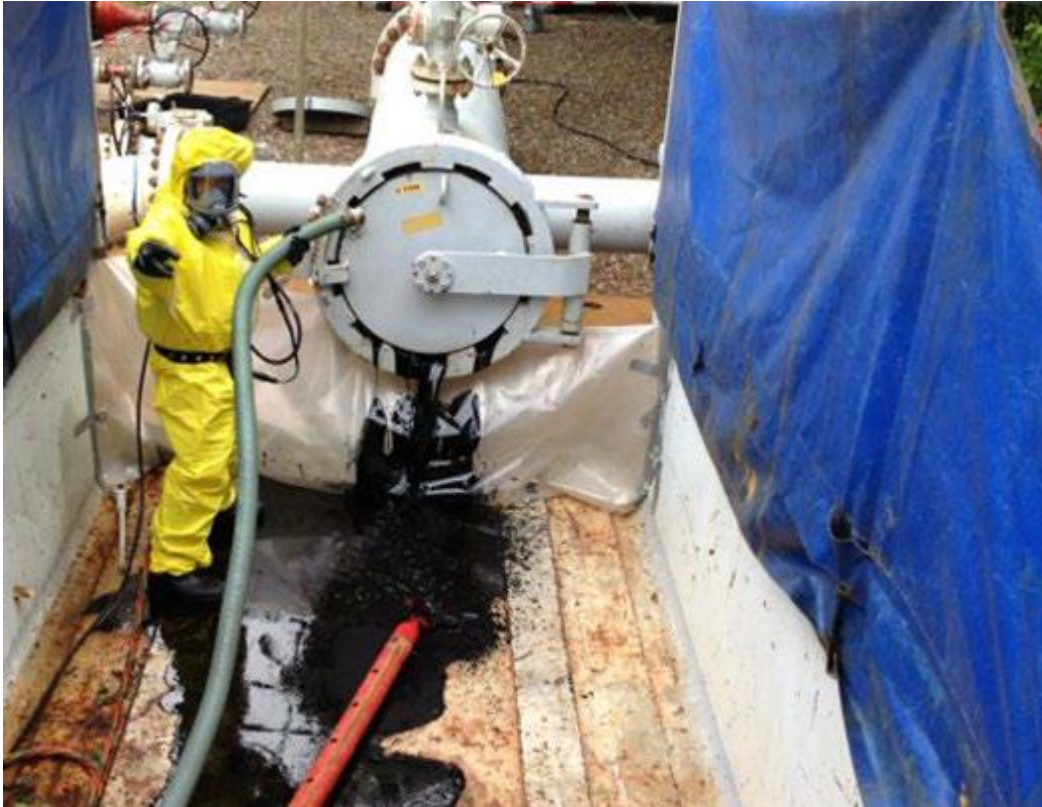
Figure 13. Opening pig receiver.

Pre-cleaning is the first step of the cleaning operation. The natural gas pipeline in question is still in natural gas service and is equipped with facilities for pigging. Pig the intended route during natural gas transport service with a bi-directional (BiDi) pig, monitor the contamination included both the amount of liquids and the amount of solid. Repeat this step several times until the contamination found is less than 1-2 liter solid/liquid (depending on the pipe diameter: 1 liter for pipelines up to 12 inches and 2 liters for pipelines longer than 12 inches). The reason for use of BiDi pig is, if the pig for some reason gets stuck in the pipeline, there is the possibility to divert.

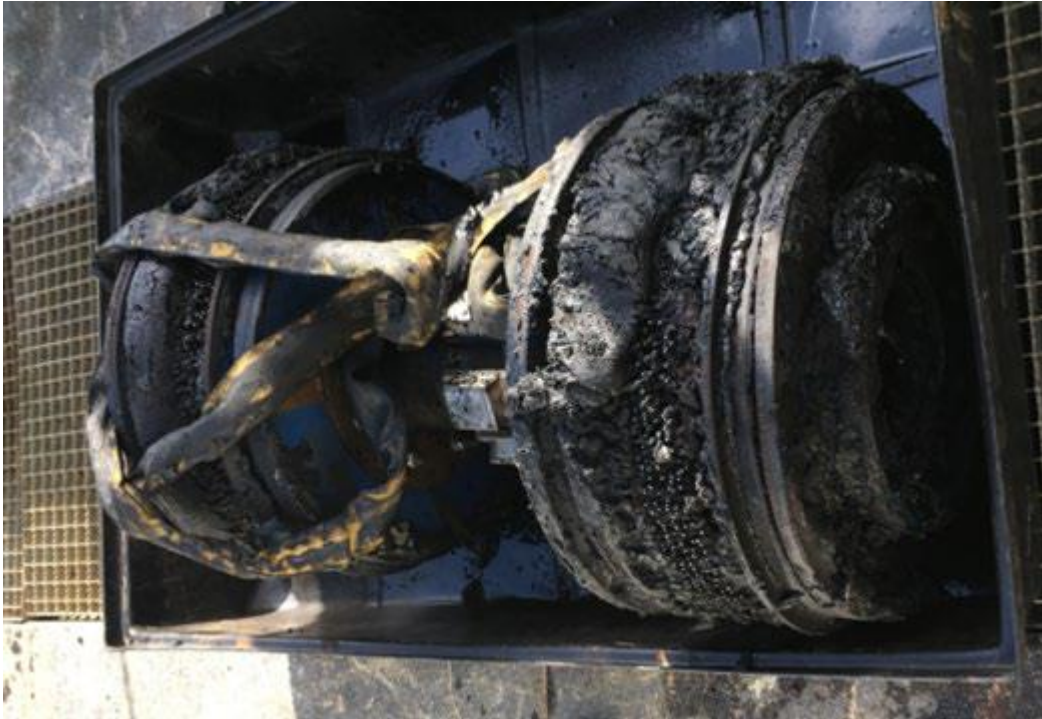
Figure 14. Dirty tool after pigging a natural gas pipeline.

The fourth step is to perform a cleaning pig-run using a BiDi-pig under nitrogen atmosphere and monitor the contamination found. Depending on the contamination found (welding pellets etc. or whether liquids have also been introduced), perform an extra pig-run if necessary, until the pig is found dry and clean in the receiver. Wait before transferring the system to hydrogen until an affected pipeline section can become part of an operational hydrogen network (i.e., allow residual volatile components from the natural gas operation phase to evaporate as long as possible in the nitrogen monitoring phase, thus preventing them from contaminating the hydrogen in the initial phase).
